Evaluation of Restoration and Revitalisation Opportunities of Historical Industrial Heritage in Protected Area of Bilecik-Söğüt (Türkiye)

Dr. Fatma SEDES , Asisst. Prof.Dr.(Istanbul Aydin University)
Ayhanberk IRDEN , Architect M.S.(Istanbul Aydin University)

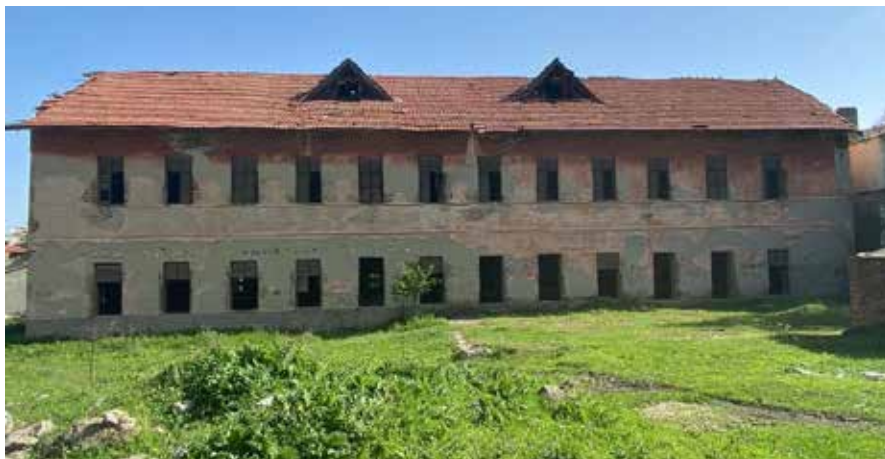
Figure .3: General view of the front of the building from the outside Source: (Irden, A. 2021)

The tiles on the roof cover should be collected and removed from the surface. Original tiles should be identified and preserved in place. If there are lichen and moss formations on tile surfaces, they should be chemically removed from the surface.

Strength and material tests of wood should be made on wooden roof trusses, flooring covering, beams and columns, stairs, doors and window shutters, and solid wood should be protected in place.

Plant problems that partially or indirectly affect the structure should be mechanically and chemically removed from the structure.

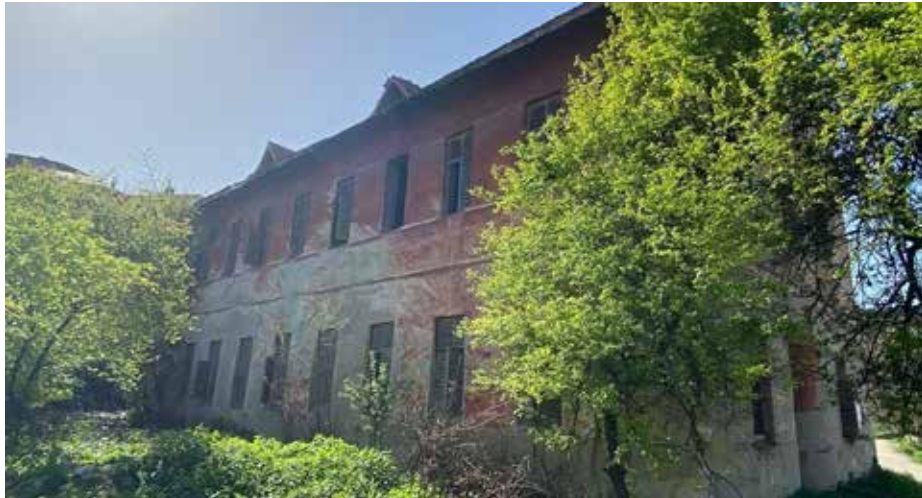
Fig. 4: General view of the back of the building from the outside Source: (Irden, A. 2021)

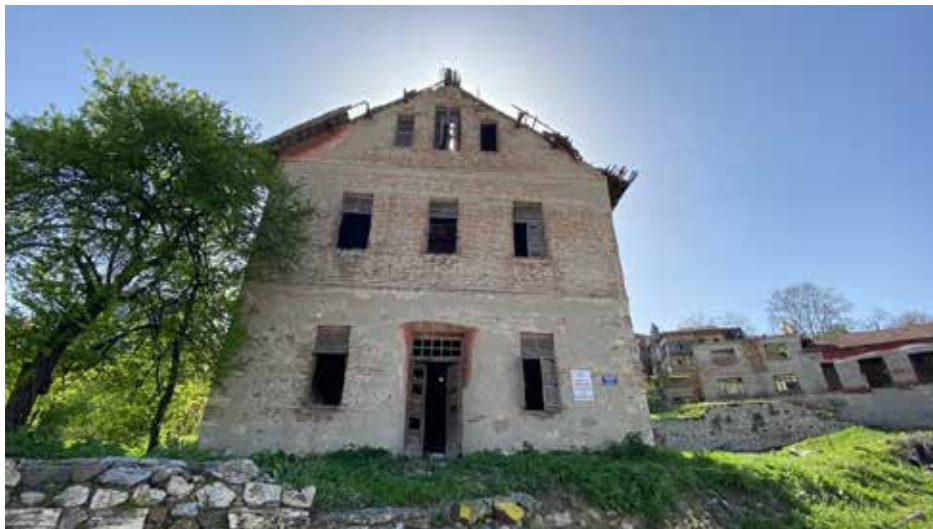
Fig. 5: Relief drawing of the north (rear) facade of the building Source: (Irden, A. 2021)

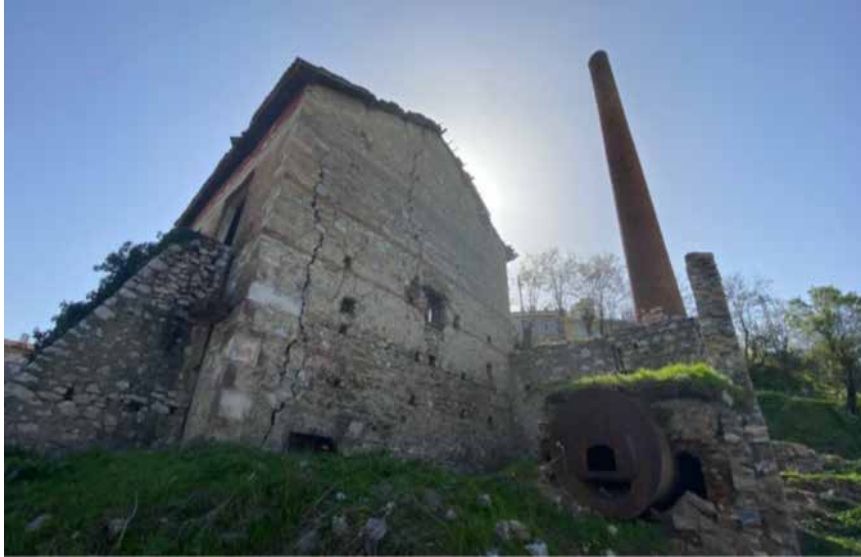
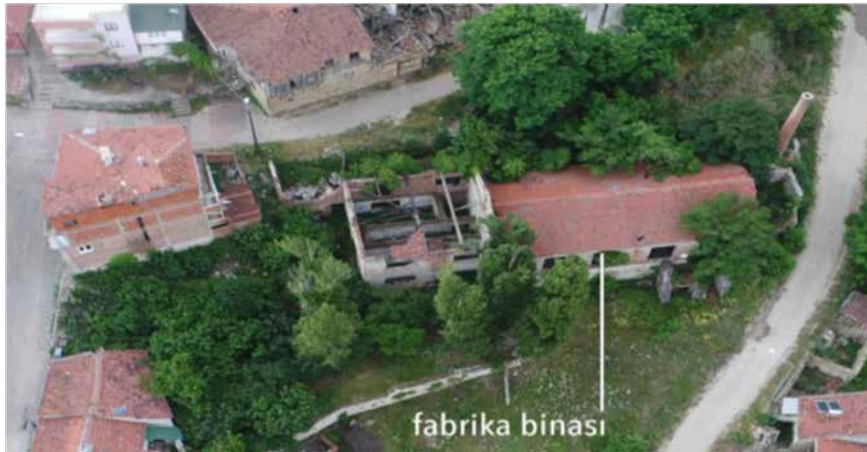
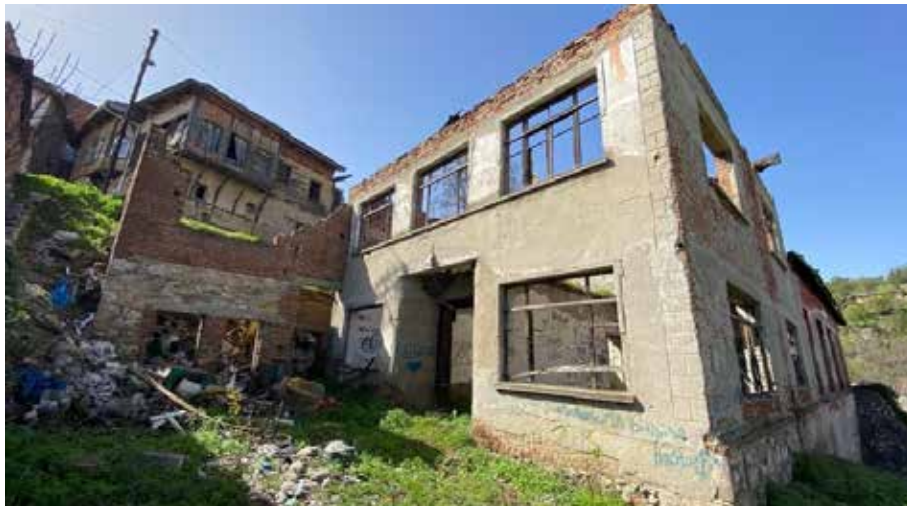
Fig.7 Source: (Irden, A.) Fig.8 Fig.9 Source: (Irden, A).

The Silk Factory building is located on Hankaya Street, in the southern part of Söğüt city center. The residential area of the building, which is located in the district center, on a land inclining to the north, is 528.29 square meters. It is a two-storey building with a rectangular plan. In addition to this building, there is a rectangular and two-storey building. It has entrances from the north and east. There is a boiler and chimney belonging to the building in the south. The building, which was one of the most important silkworm breeding buildings of the period, is in ruins and ruins today. The survey studies of the silk factory No. 2 were made, conservation proposals were made and a new function proposal was presented. The Silk Factory building was built with brick masonry technique. When the materials used are examined, it consists of the ground floor and the first floor, which are thought to belong to two different periods. All of the windows of the building are damaged and only structural gaps are visible. The load-bearing construction of the masonry walls consists of terracotta (clay) brick and mudbrick material components. Wooden material is used in horizontally arranged floor and beam elements. There is a Marseille tiled cover on the roof. In addition to the building, another building was built. It can be seen that these additions made in different periods are different from the original state of the building. The roof of the annex has completely disappeared and the building is unusable (Figs.7,8,9).

The existing cast boiler in the boiler room of the building should be cleaned mechanically and chemically and protected by applying a transparent protector.

It should be examined whether the brick chimney connected to the boiler room has any static problems, and a transparent protector can be applied to the bricks by cleaning the surfaces.

The tiles on the roof cover should be collected and removed from the surface. The original tiles should be identified and the intact ones should be protected. If there are lichen and moss formations on tile surfaces, they should be chemically removed from the surface.

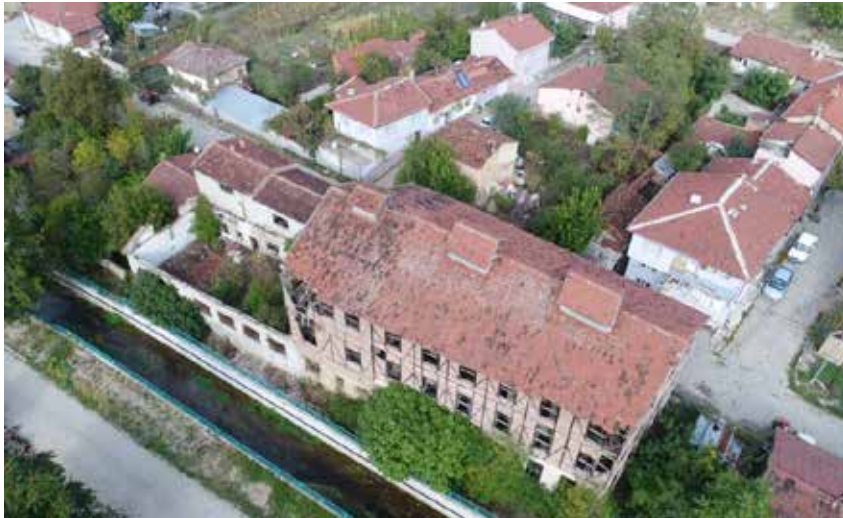
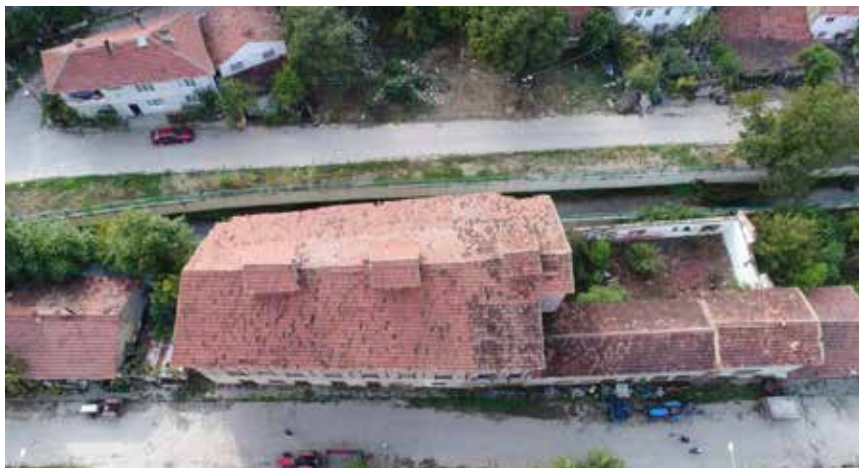
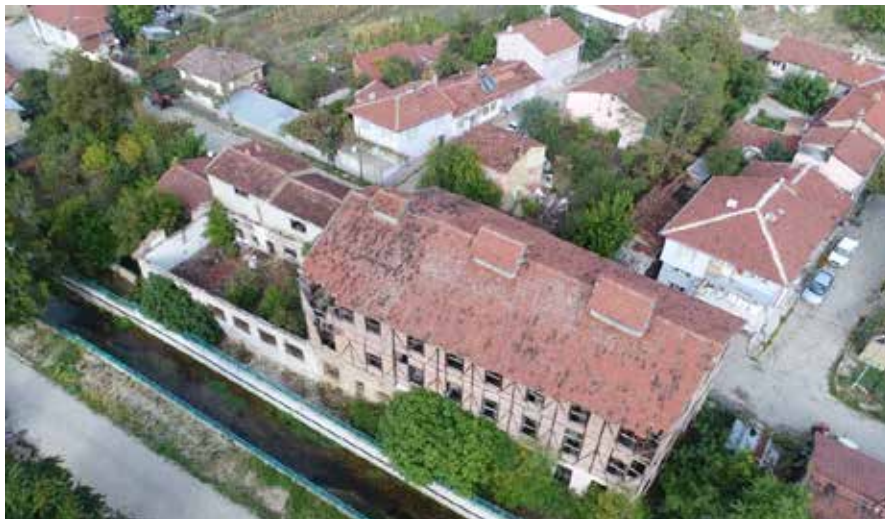
The Silk Factory building was built in the wicker construction technique. Some of the windows and doors of the building were damaged. It consists of stone material components as a filling between wooden carcass elements. Wooden material is used in horizontally arranged floor and beam elements. There is a Marseille tiled cover on the roof. In addition to the building, another building was built. It can be seen that these additions made in different periods are different from the original state of the building. The façade was damaged on the south-facing façade of the building, and the roof of a part of the annex was completely destroyed. Factory building and annex building are unusable (Fig.11,12,13)

Roofing tiles should be collected and removed from the surface. Original tiles should be identified and preserved in place. If there are lichen and moss formations on tile surfaces, they should be chemically removed from the surface.

Strength and material tests of wooden roof trusses, flooring covering, beams and columns, stairs, doors, window shutters and rattan wood should be done, and the solid wood should be protected in place.

Repairs made with cement-added materials in the following periods should be removed from the building. Due to the water channel passing right next to the building, it should be investigated whether there are salinizations caused by moisture in the building, and if it is detected, salt intake should be done.
