Arif Pasha Mansion From its First Construction to the Present

Abstract

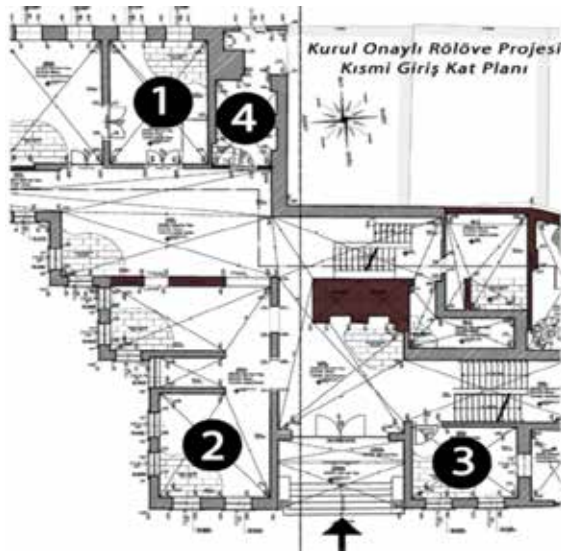
Fig 11.

1. Ceilings with hand-drawn decorations have been eroded due to incorrect and faulty blasting in previous periods.
2. The surface deformations as a result of the wrong scraping work caused the colors and textures of the patterns, and the details in the motifs to be mostly lost. Necessary works to be done in hand-drawn work; very careful paint scraping ought to be done on all surfaces.

- 3-Making hand-drawn surface cleaning on the surfaces whose scraping has been completed.
- 4-Taking the existing patterns, correcting, duplicating, transferring the motif to the surface by pinning.
- 5-Preparation of colors.
- 6-Clapping.
- 7- Drawing of flats, drawing of den dans apart from corner and core motifs.
- 8-Studying corner and core motifs.
- 9-Making light and shadow details in motifs.
- 10-Coloring the ground cores.

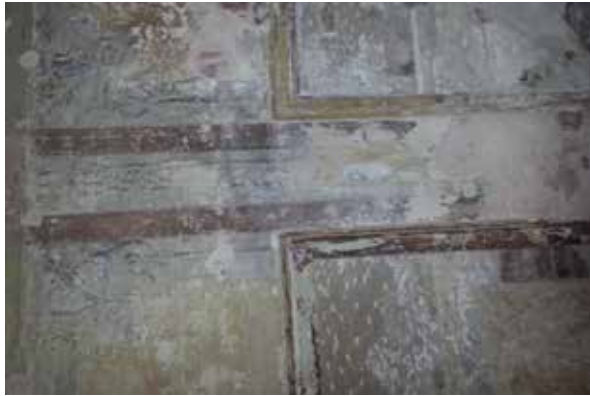
Fig.12

Hand-drawn Conservation Suggestions: Deterioration was observed in the hand-drawn decorations on the ceiling and walls. The plastered surfaces on which the hand-drawn decoration is applied have undergone physical changes and deformation has occurred in some parts. Acrylic-based paint was made on it in various periods. The paint used on the hand-drawn work was also affected by the resulting deterioration and some losses were incurred.

has been. Depending on the preservation of the existing tissue intended for conservation; Paint removal should be done, consolidation and cleaning of the contamination on the surface should be carried out. Borders and decorations,(Fig12) the continuation of which can be predicted, should be completed with suitable materials, those that cannot be cleaned and painted should be revived, but should be preserved as they are.

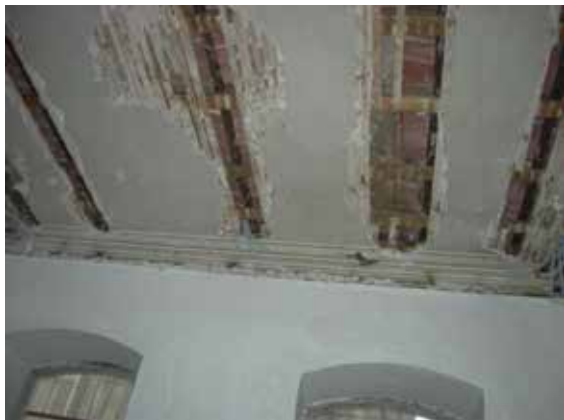
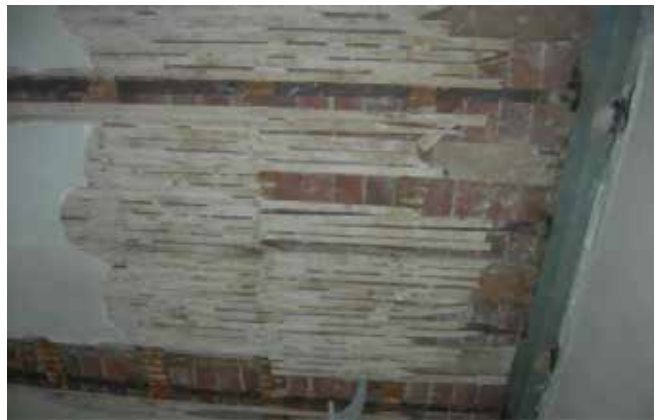
Fig.14

Room No. 3: After the scraping process on the floor, volta floor elements, tie-dye laths and wooden ceiling moldings were exposed Figs.(14,15).
