## **Restoration Process of an Assyrian Monastery – Deyrulzafaran in Mardin** **Relic of ancient times Deyrulzafaran Monastery**

Fatma SEDES Ass.Prof.Dr.  
Istanbul Aydin University

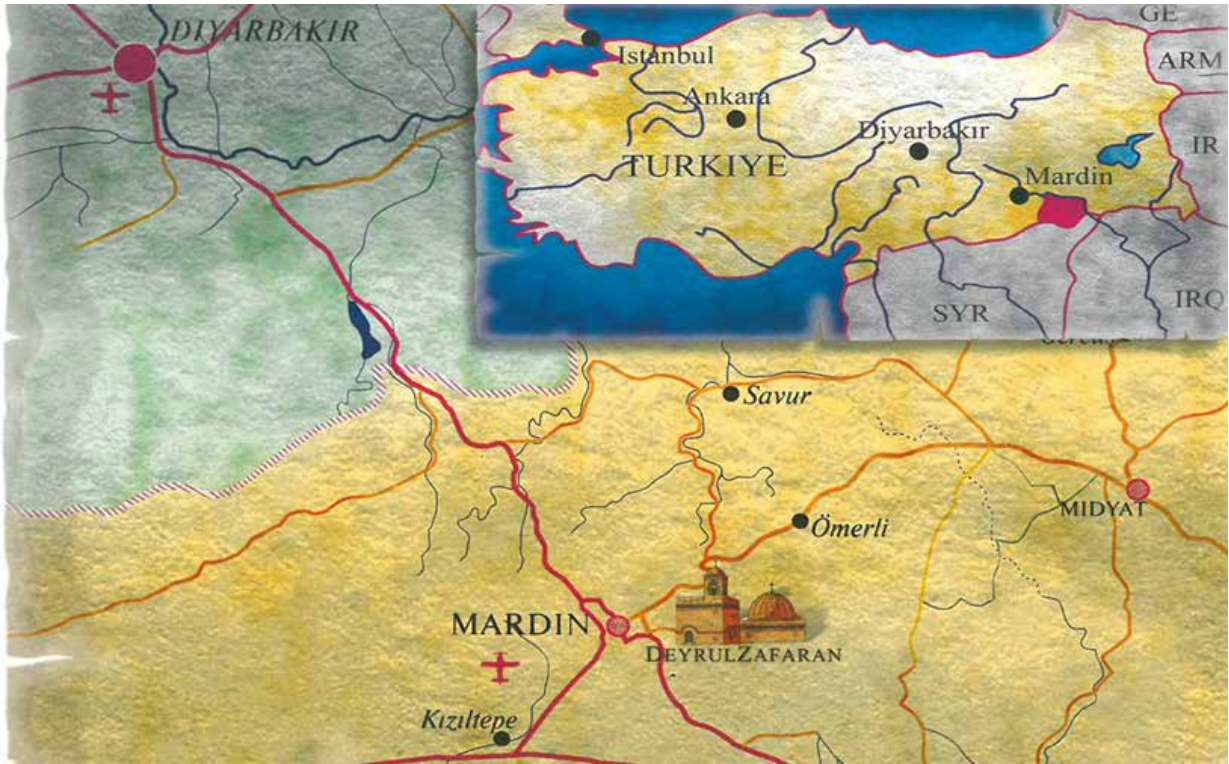
Fig.1.

The monastery, which is known as Deyrulzafaran (Saffron Monastery) in Mardin, Türkiye (Fig.1) , after the saffron plant growing around the building since 15th century, consists of three churches built in different periods, the House of Saints (Beth Kadise), a “divanhane” and a large courtyard surrounded by priests’ rooms.

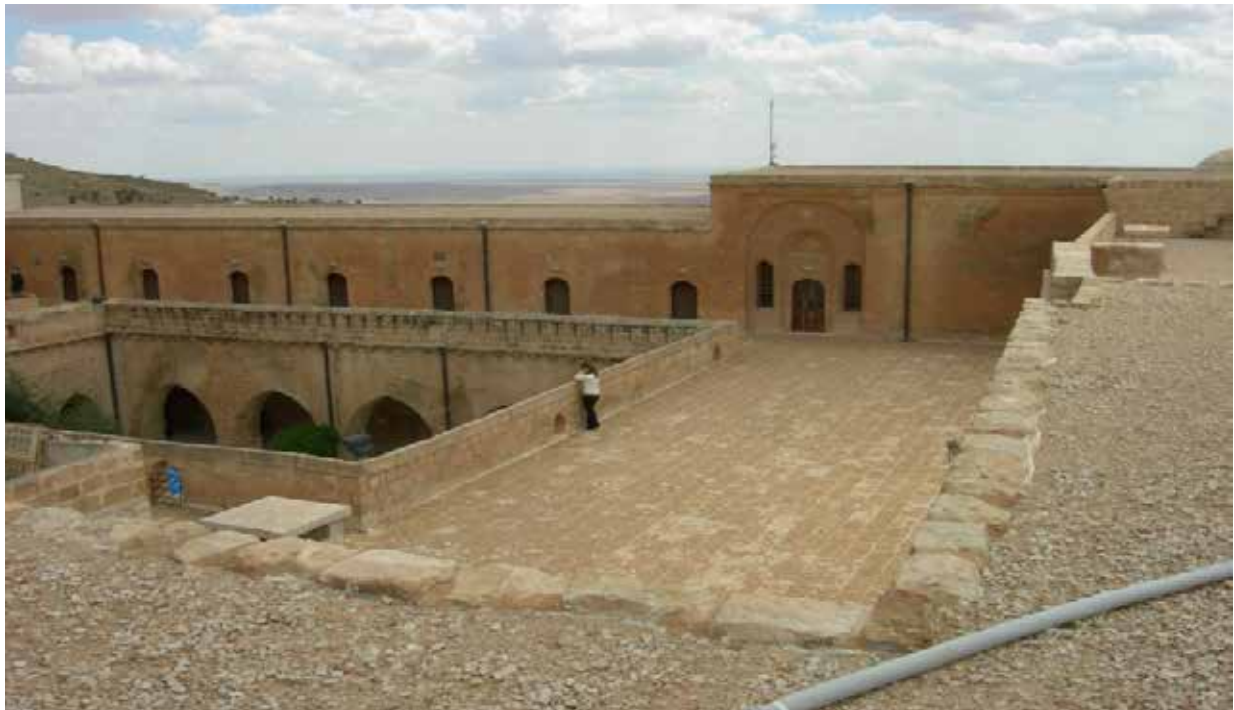
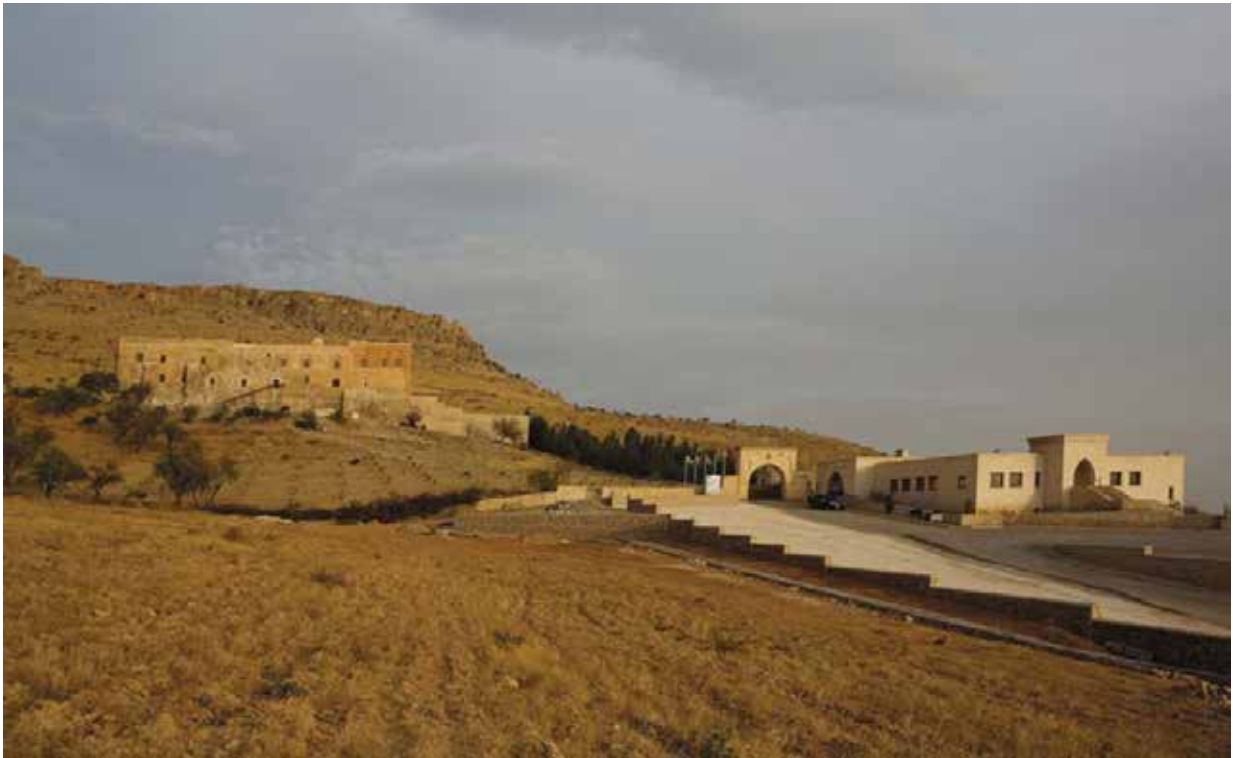
Fig.2.

Divanhane, priests’ rooms and visitors’ rooms, inner courtyard, service units, kitchen, laundry and dining hall, monastery front and side garden (Firdeyso), iwan (eyvan) with pool and corrals (Fig.2,3). Its domes, arched columns, wooden hand engravings, interior and exterior stone of the Monastery attracts attention with its embroidery (stone ornaments ) (Fig4,5). It continues to function as a Metropolitan Center covering the Provinces of Elazig (a city in Eastern Anatolia).

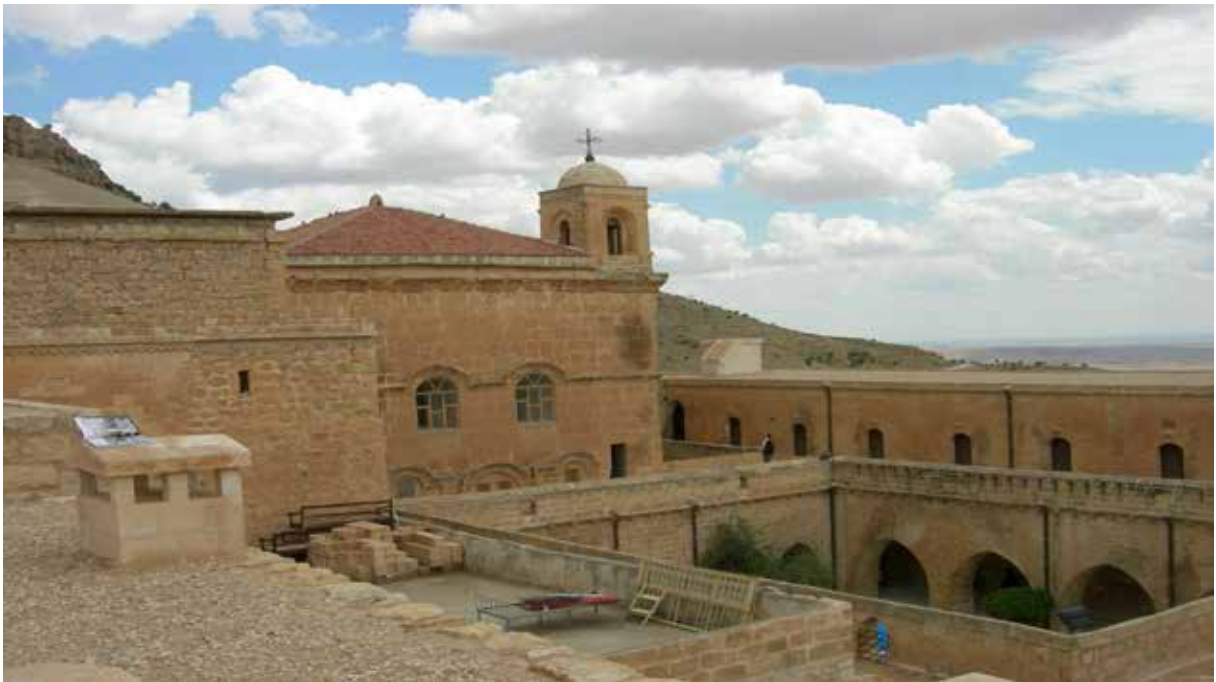
Fig.7.

The Association determined the current state of the Monastery and made a survey, preparing restoration projects and getting them approved by the Restoration Board, to produce and adopt protection-priority policies (Fig7).

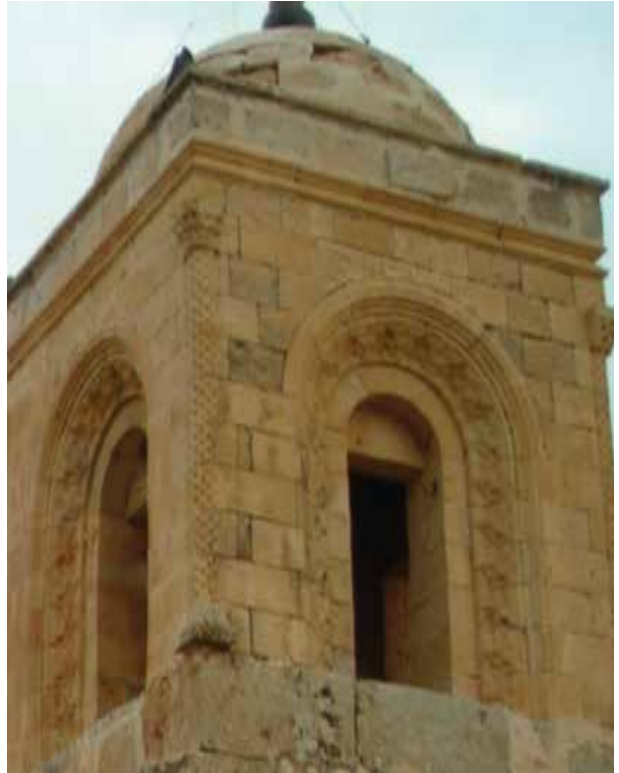
Fig.9

to restore the original cover, to improve the isolation conditions of the terraces and converting from cement pavements to stone. Interior restoration of Hananyo Church and House of Saints' (with Bell Tower) and Saints' graves (Fig.9). As a requirement of this, special attention was given to the use of original materials and cement use was kept to a minimum. Mor Hananyo Church and in the restoration of the House of Saints. The local authorities helped to complete the missing parts with the stone taken from the quarries. Hydraulic lime and cream lime (to make the Khorasan mortar) was used in joint plaster as a binder. There are two striking features in the main apse of the Mor Hananyo Church.

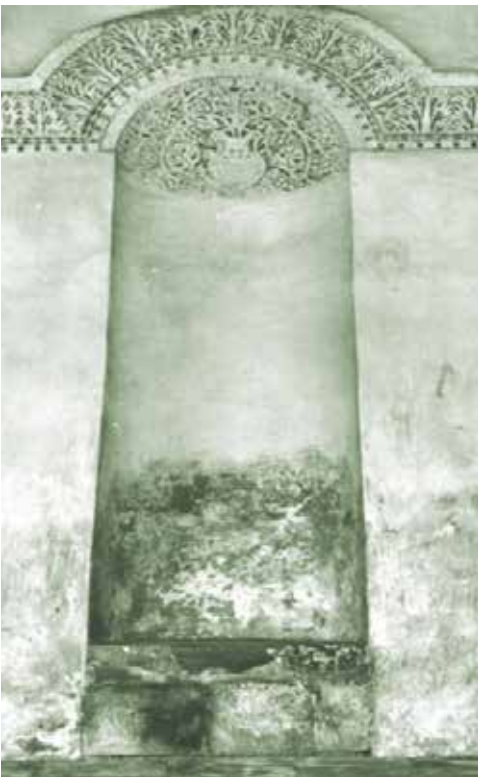
Fig.10

and cement pavements converted to original stone. The bones of some Saints and the Patriarch who served in the Monastery and the section where the metropolitans were buried also restored. In the completion of the missing parts in restoration, local quarried rock was used. "Khorasan" to be used in plaster hydraulic lime and cream lime to make the mortar. One of the most striking features of the Deyrulzafaran Monastery are stone motifs found on the entrance door and indoors. Thus, Deyrulzafaran Monastery occupies a special place in the history of art and architecture in the region among other mosques, churches and monasteries (Fig.10).

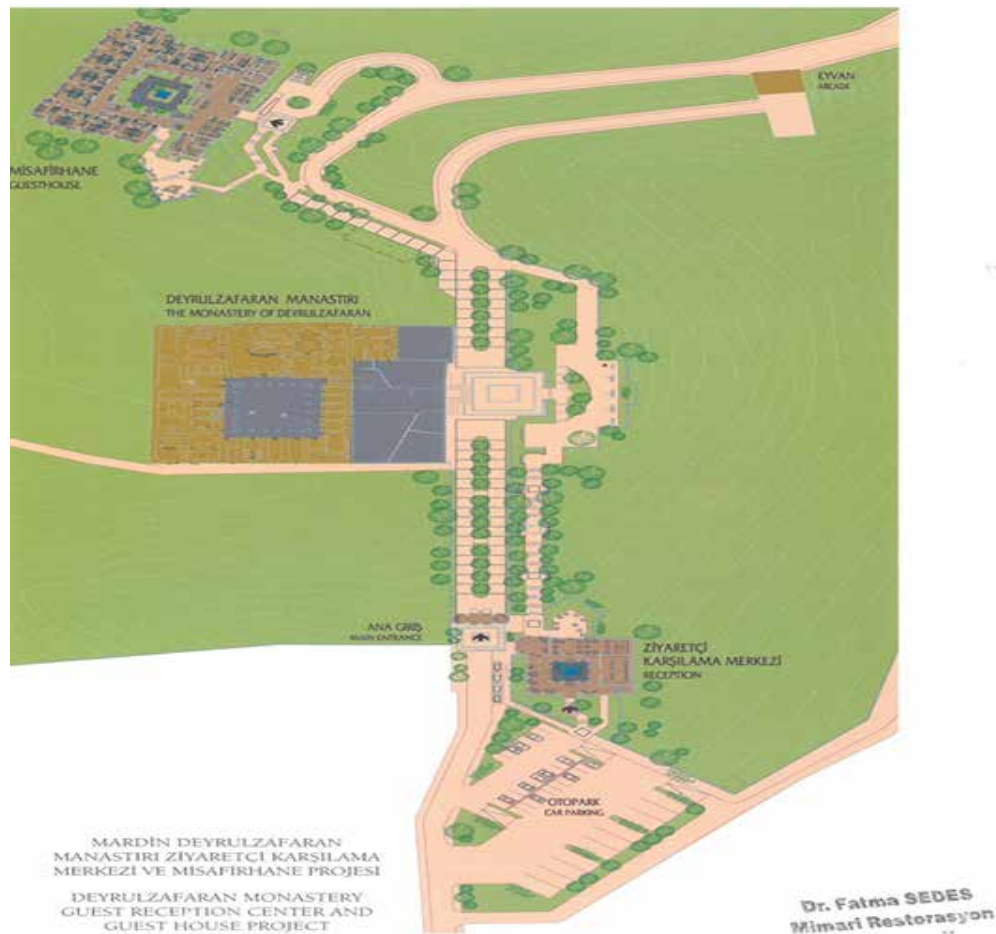
Fig.11  
DEYRULZAFARAN  
Manastırı Bakım  
Onarım Yaşatma  
Derneği, İstanbul,  
2004

This is a very important work feature in terms of cultural, aesthetic, technical and symbolic restoration project. And its implementation carried of great importance. In this context, the maximum use of the original materials and techniques took place. Cement screeds damaging the structure of terrace, were carefully taken over the roofs without damaging the original layers underneath. (Fig11).

After the dismantling work is done, in accordance with the waterproofing details, LIC was created. Meanwhile, the missing gargoyles were found in local stone-was manufactured and replaced. Deletions that have lost their properties with chipped stone were completed. The chimneys in the strata were repaired and handled visually and functionally. The covers were made of local stone.

The cement screeds that damaged the structure of the Deyrulzafaran Monastery were carefully removed from the terraces and roofs without damaging the original layers underneath. After the dismantling work was done, the base was created in accordance with the water insulation details. In the meantime, the missing gargoyles were made of local stone in accordance with their samples and put in their place. The erasures that lost their characteristics were completed with a directional stone. The parapet walls, which are incomplete and damaged, have been restored to their former level in accordance with the material and weave texture. In addition to these, the chimneys on the terraces were repaired and handled visually and functionally, and the chimney caps were made of local stone.
