Evaluation of Restoration and Revitalisation Opportunities of Historical Industrial Heritage in Protected Area of Bilecik-Söğüt (Türkiye)

Dr. Fatma SEDES , Asisst. Prof.Dr.(Istanbul Aydin University)
Ayhanberk IRDEN , Architect M.S.(Istanbul Aydin University)

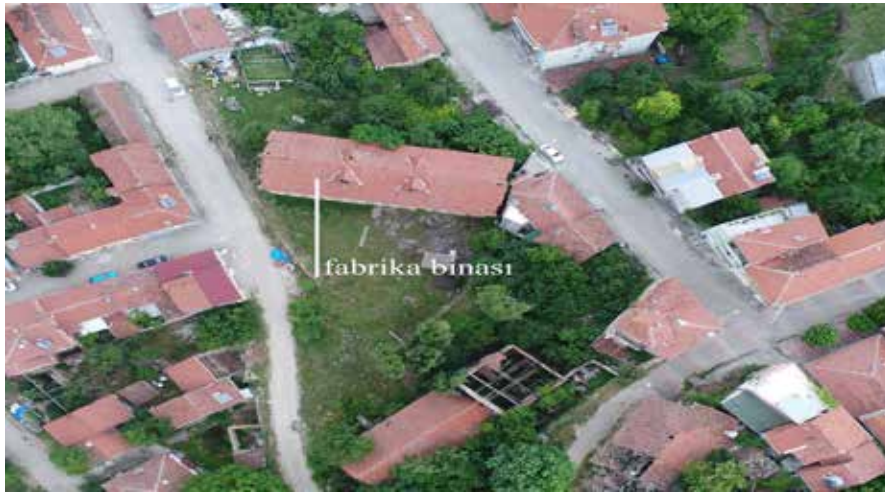
Figure 1.: Relationship of the Silk Factory No.1 with its surroundings Source: (Irden, A. 2021)

çade of the building. There are one and two storey settlements around the other facades. The building, which was one of the most important silkworm breeding buildings of the period, is in ruins and ruins today. The survey studies of the silk factory No. 1 were made, conservation proposals were made and a new function proposal was presented.

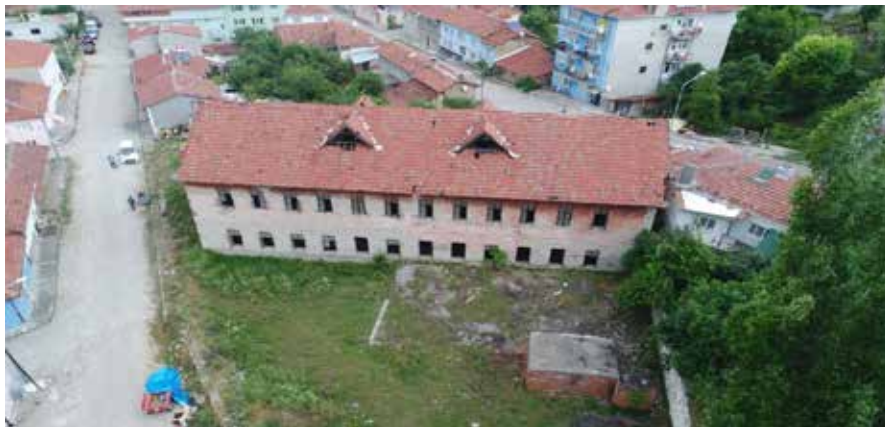
Figure 2: Aerial view of the Silk Factory No.1 with a drone Source: (Irden, A. 2021)

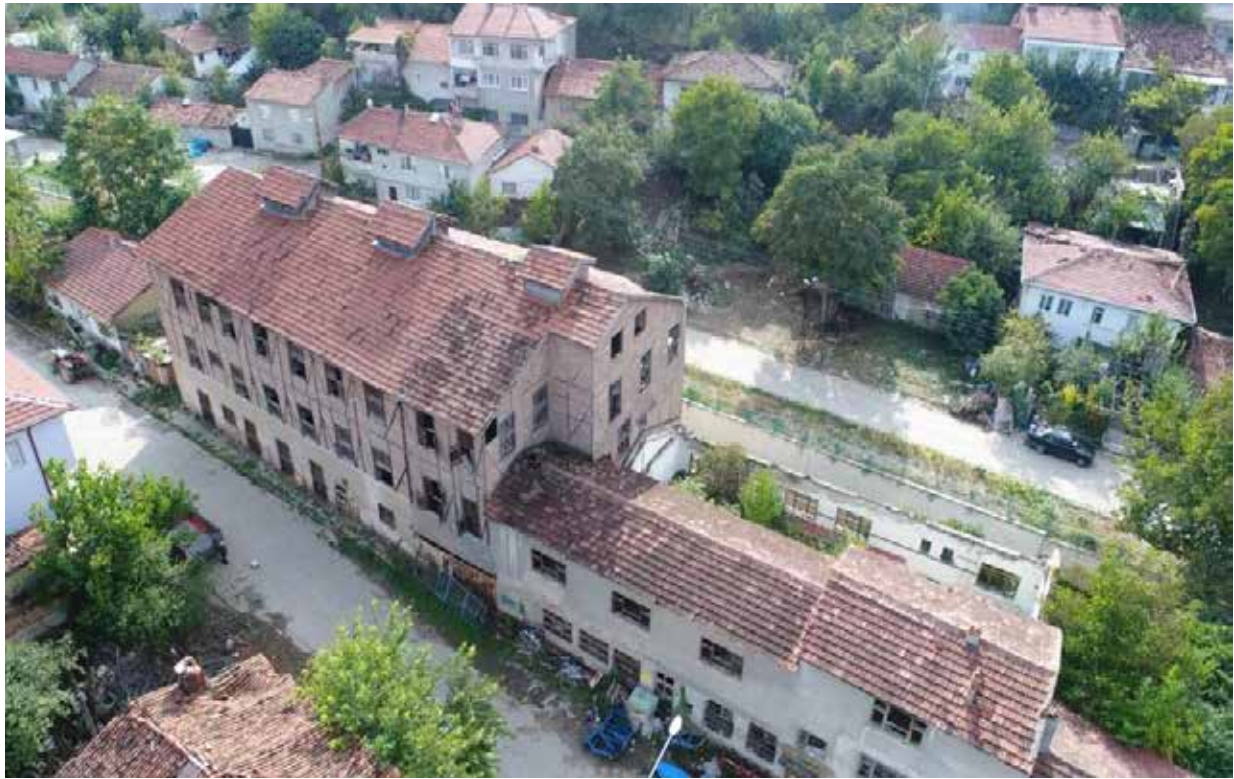
Fig.10 Source: (Irden, A. 2021)

3.1 Location, building identity and features Silk Factory Building No. 3 is located in the southern part of Söğüt city center, on Sünnetçi Street (Fig.10). The residential area of the building, which is located in the district center, on a land inclining to the north, is 774.96 square meters. Except for the additions, the living area of the building is 316,02 square meters. It is a rectangular structure and its entrance is from the north. It consists of ground floor, upper floor and attic floor. The factory building is located right next to the Söğüt Stream. The building, which was one of the most important silkworm breeding buildings of the period, is in ruins and ruins today. Relief studies of the silk factory No. 3 were made, protection suggestions and a new function proposal were presented.
