Arif Pasha Mansion From its First Construction to the Present

Abstract

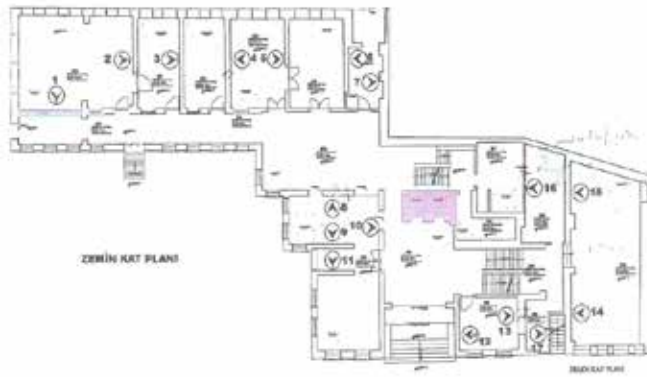
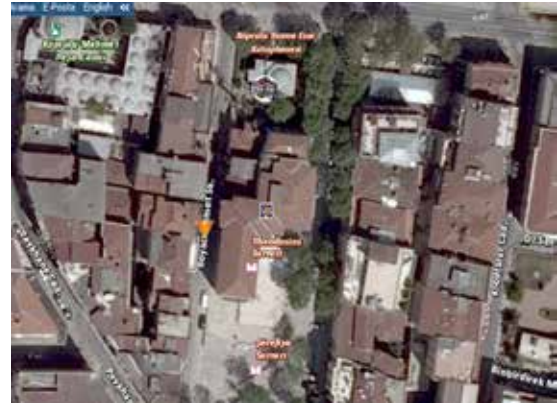
(Koçu 1975). During the survey, restitution and restoration projects carried out in the building, which was also used as the “Eminönü Municipality Building” between 1984-2009, it was understood from the observations and material analyzes on the building that it served more than one purpose from the date it was built to the present day and that the building underwent changes for these uses (Figs. 1, 2)

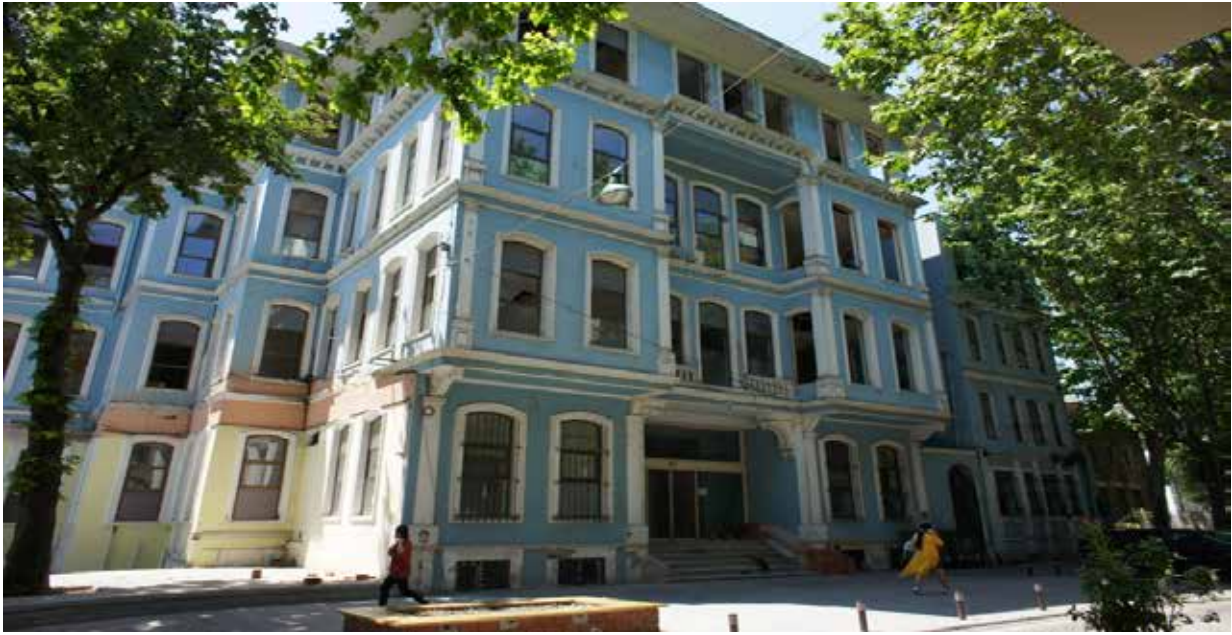
Fig 3.

Later, it was used as the conservatory building (Darul Elhan) in the late 1920s (Rey, C.R.1949) and served as the Eminönü Municipality Building from 1984 to 2009(Figs.3,4). During this period, the adjacent parcels of the building numbered 1-2-3-4-5 were consolidated and an additional service building was built, and the additional building was demolished in March 2010 due to the damage it caused to the Şerefiye Cistern below it (Sedes, F.2008).

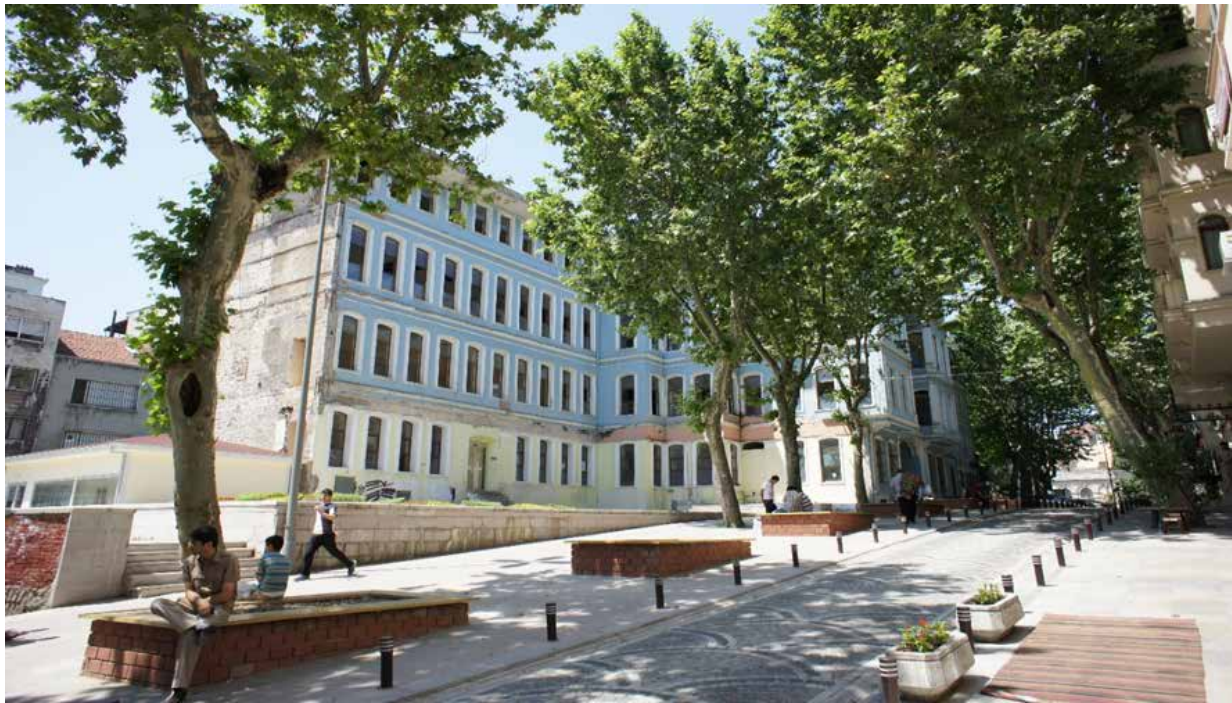
Fig.5

as the “Eminönü Municipality” building between 1984-2009, it was understood from the observations and material analyzes on the building that it served more than one purpose from the date it was built to the present day and that the building underwent changes for these uses.(Figs.5,6).

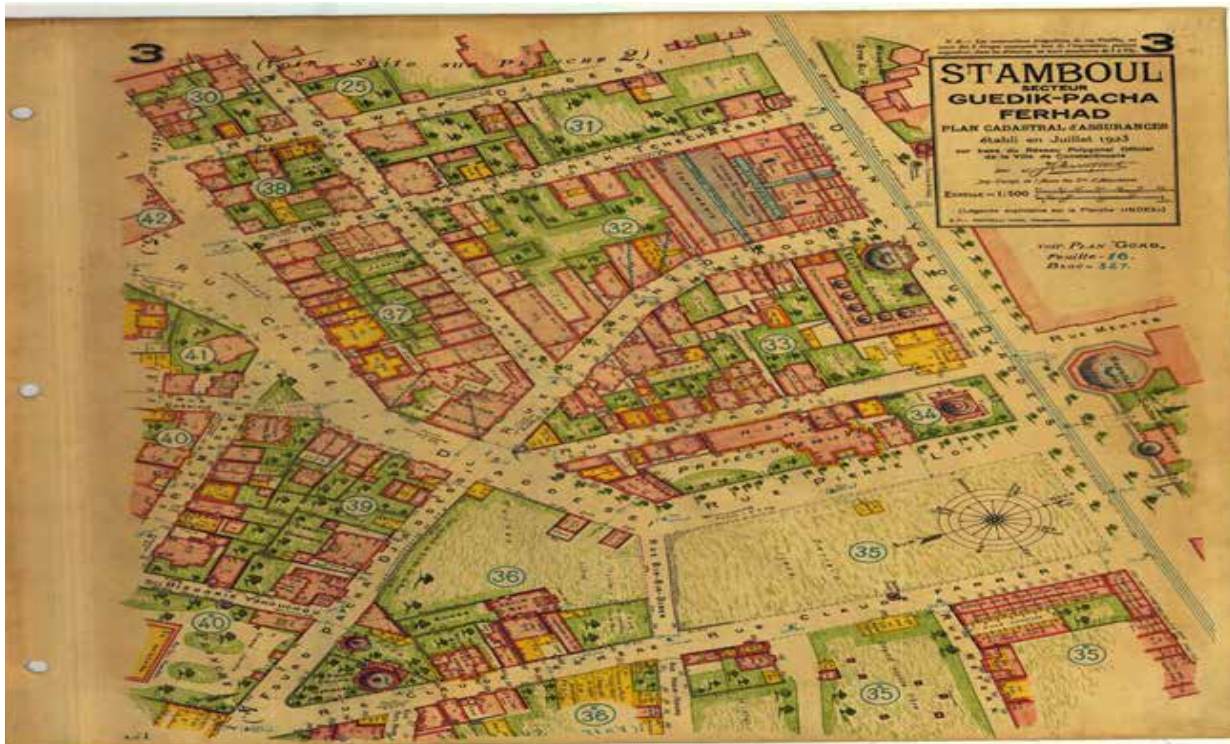
Fig.7

In the last examination, it was determined that the thickness of the two rubble stone walls in the basement floor was wider than the 2010 board-approved survey project, and the project was drawn accordingly. These walls are expressed by scanning and in the drawing (Fig.6). In addition, the drawings of the basement floor, which were determined to be different from the approved survey, were revised and submitted to the approval of the board. In line with the accepted new situation, the basement of the building was drawn in accordance with the situation approved in

the restitution and restoration projects (Fig.7).

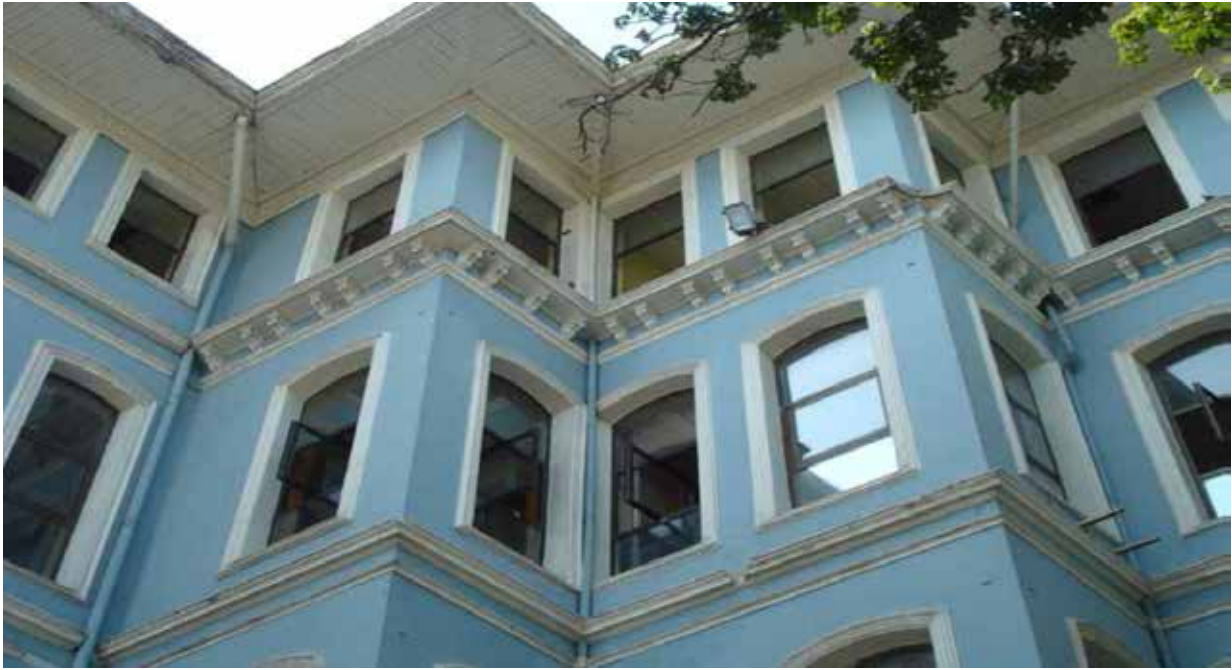
Fig.8

The main entrance door of the building is provided by a wooden door accessed via a five-step marble staircase on Pier Loti Street and opens to the entrance hall. The second entrance is in the opposite direction, on Boyacı Ahmet Street (Fig.8). The iron garden gates, which provide the entrance to the space between the social center and the main building in the north of the main building, and located at the entrance in the back section, have been preserved. The stair cores and wet areas of the building are placed on the deaf north side of the building, which does not have a view. On this front, a fire escape is also proposed due to the ease of access to the garden and evacuation.

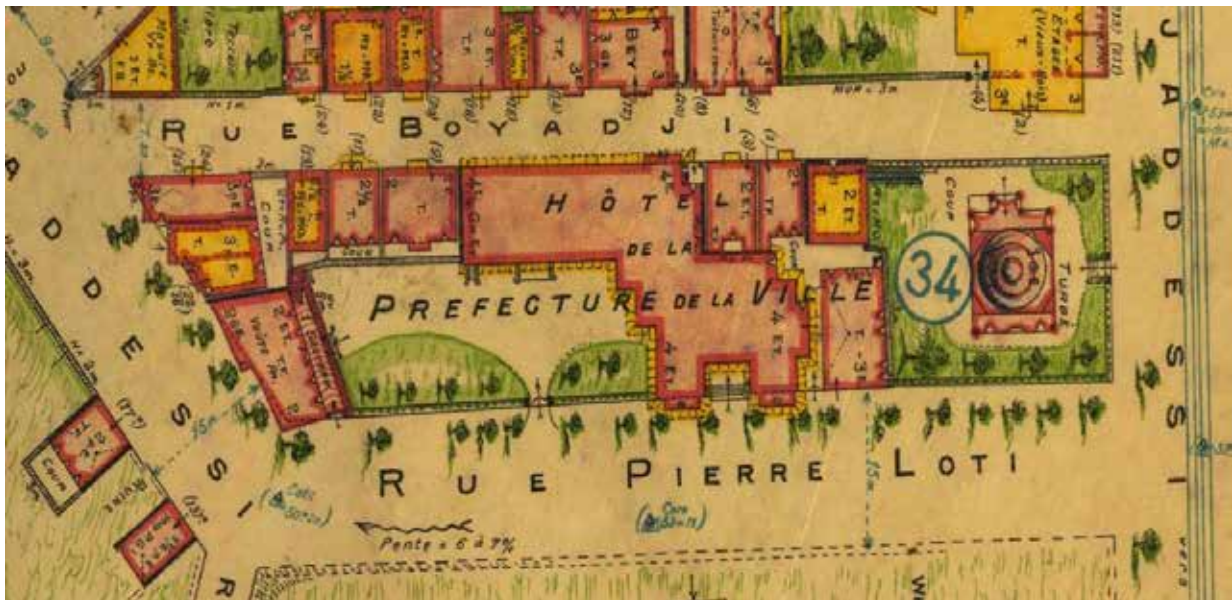
Fig.10

There are three-armed staircases and WCs in the north of the halls in the section facing Pier Loti Street (Fig.10). On the ground floor, under the middle arm of this staircase, there is a wooden door that provides access to the annex building. The staircase leading to the back hall is two-armed and is placed on the northern façade of the building, which has no view. This staircase also leads down to the basement. It is thought that there are units (archive, warehouse, etc.) serving the "Youth

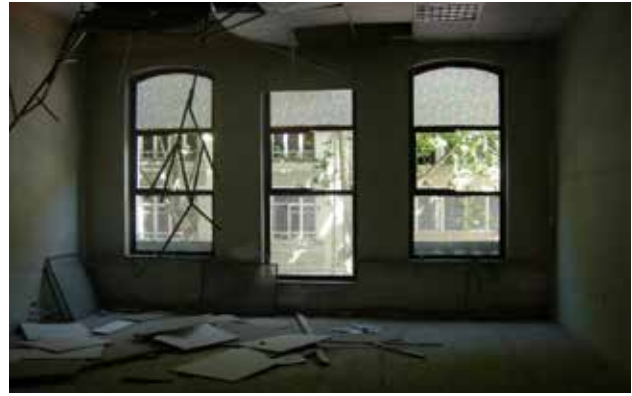
Fig.13

Room No. 4: After the scraping on the walls and ceiling, the engravings were exposed.
